# *Juneau Airport Wind System (JAWS) Wind Sensor Severe Weather Performance Test Report*

August 2002

DOT/FAA/CT-TN02/18

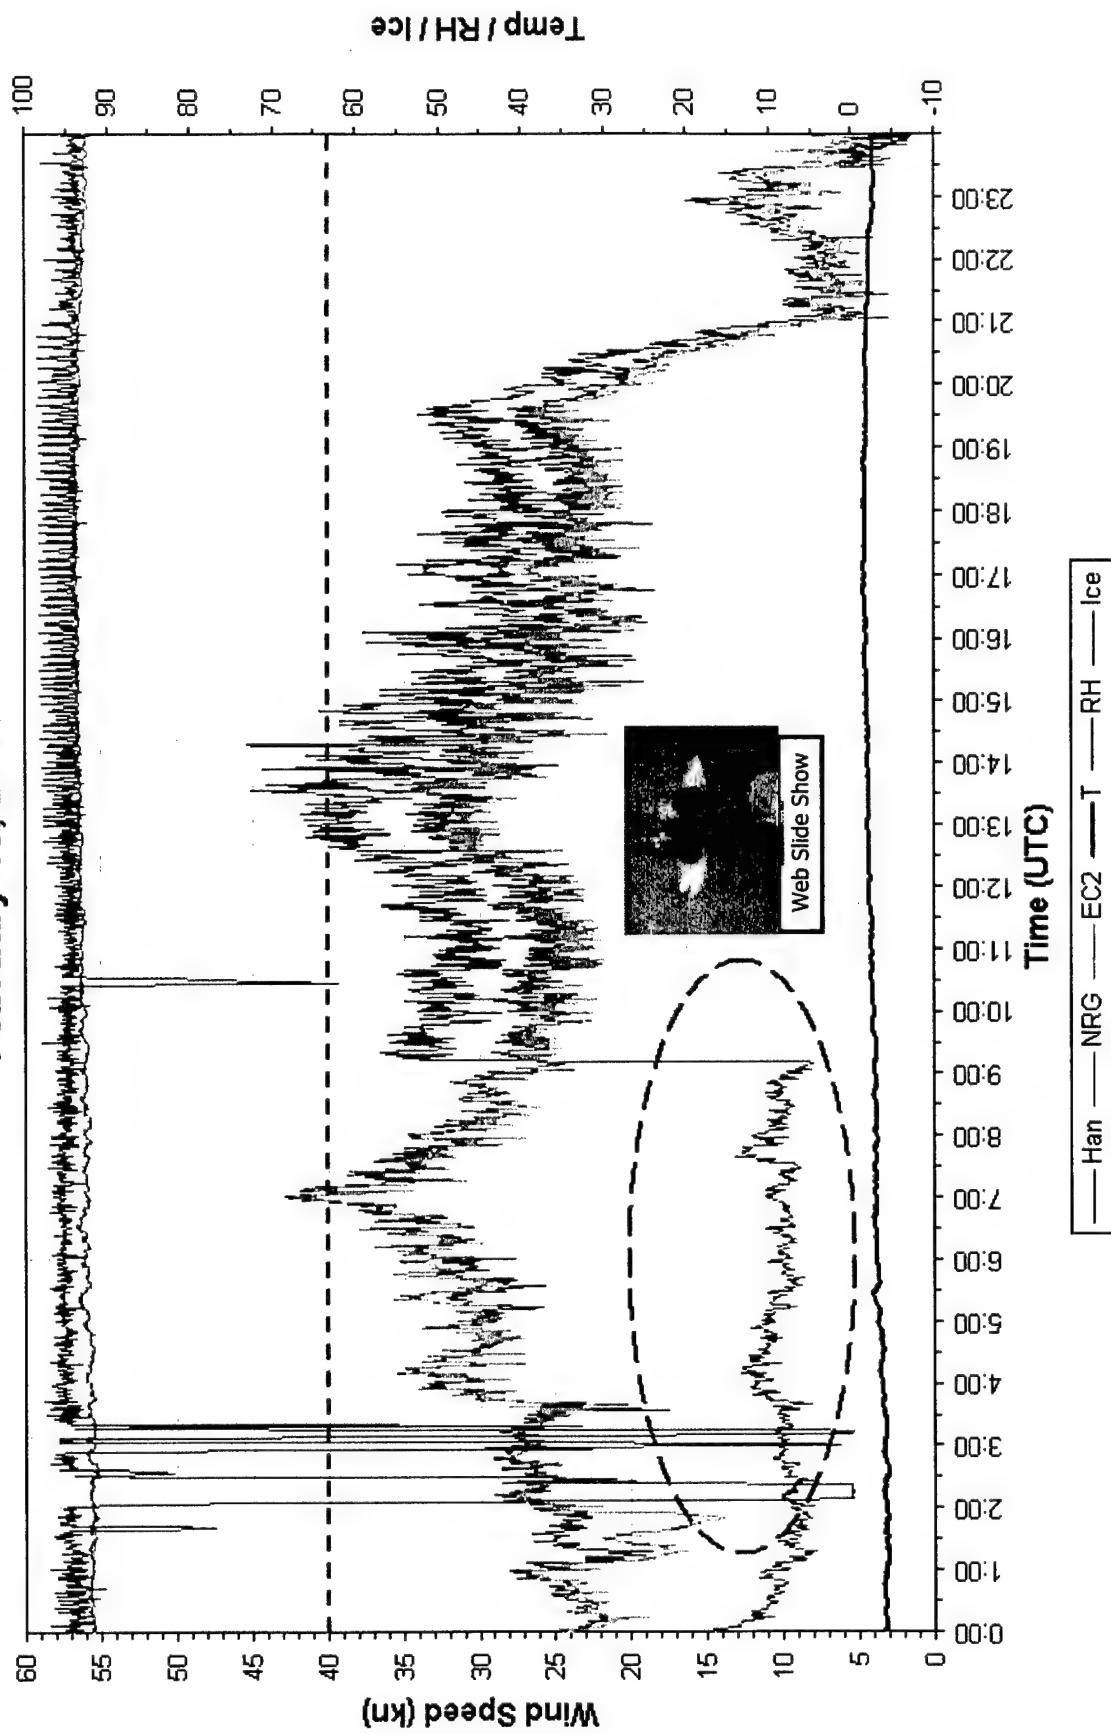
FIGURE 61. NRG ROTOR FAILURE DURING AN ICING EVENT

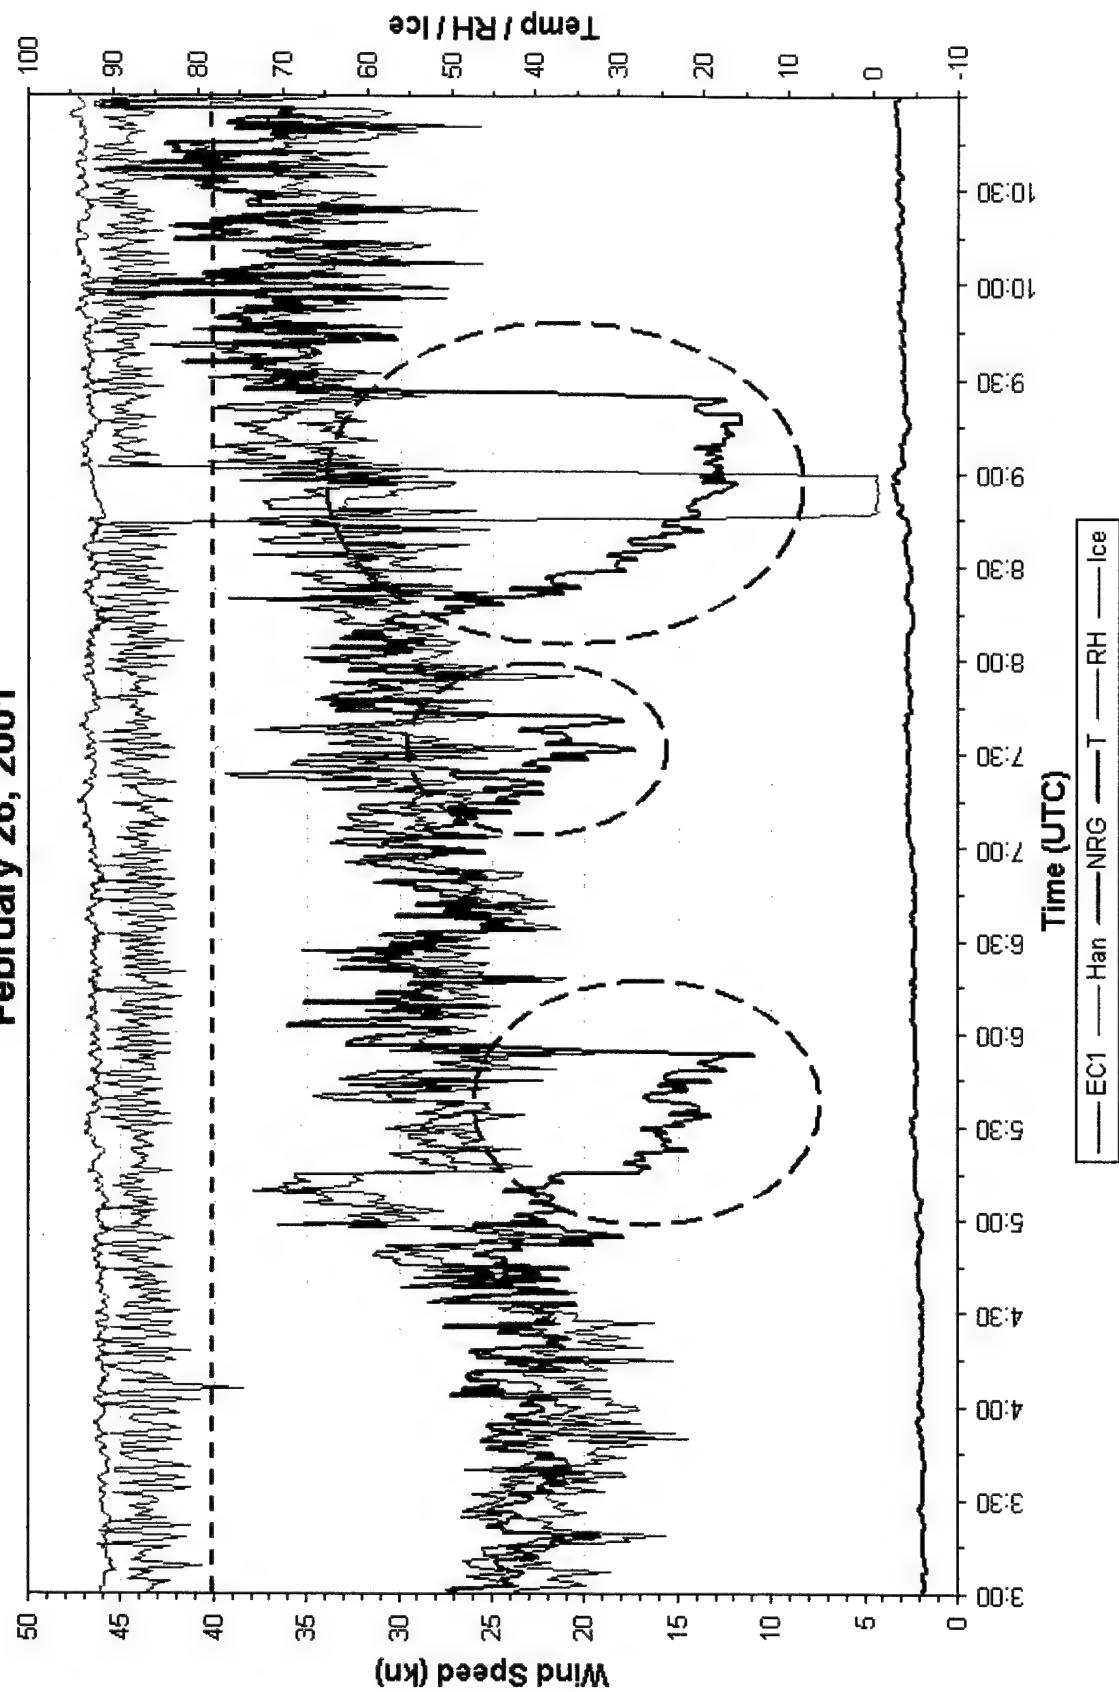
FIGURE 62. NRG ROTOR FAILURES DURING AN ICING EVENT

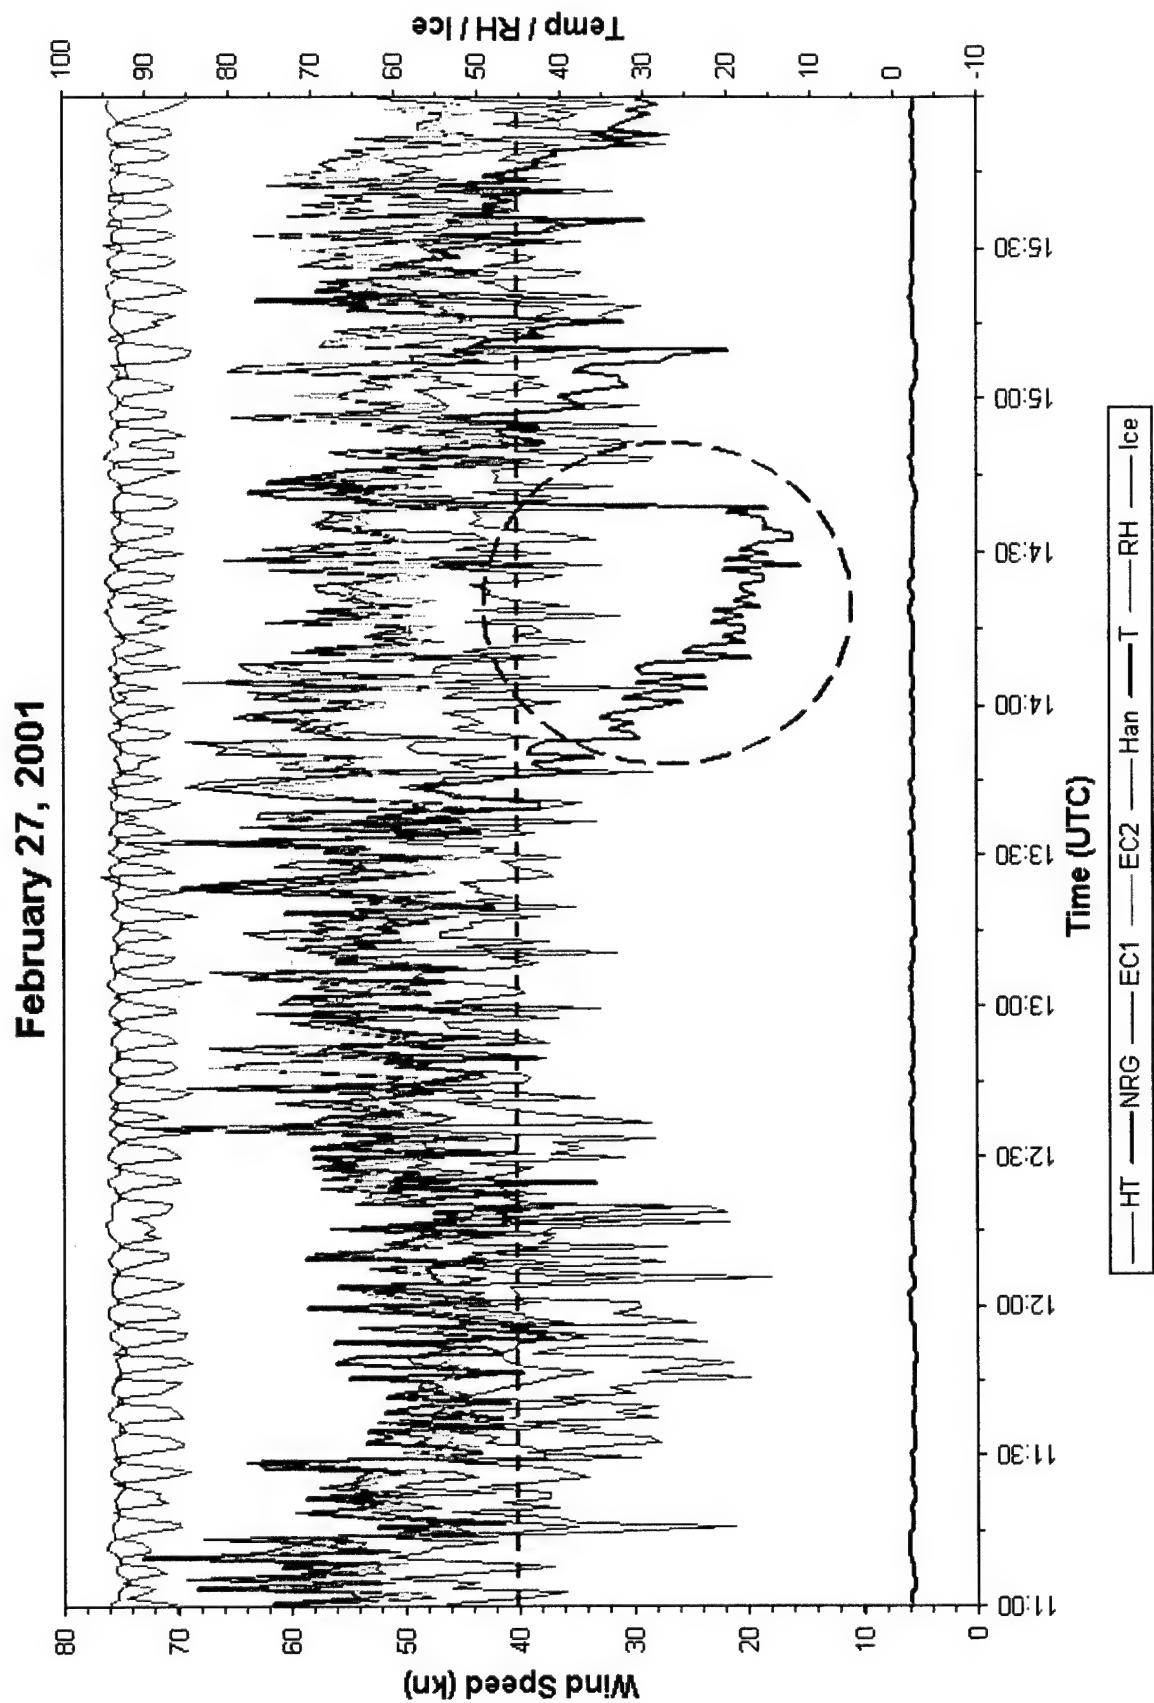
FIGURE 63. NRG ROTOR FAILURE DURING AN ICING EVENT

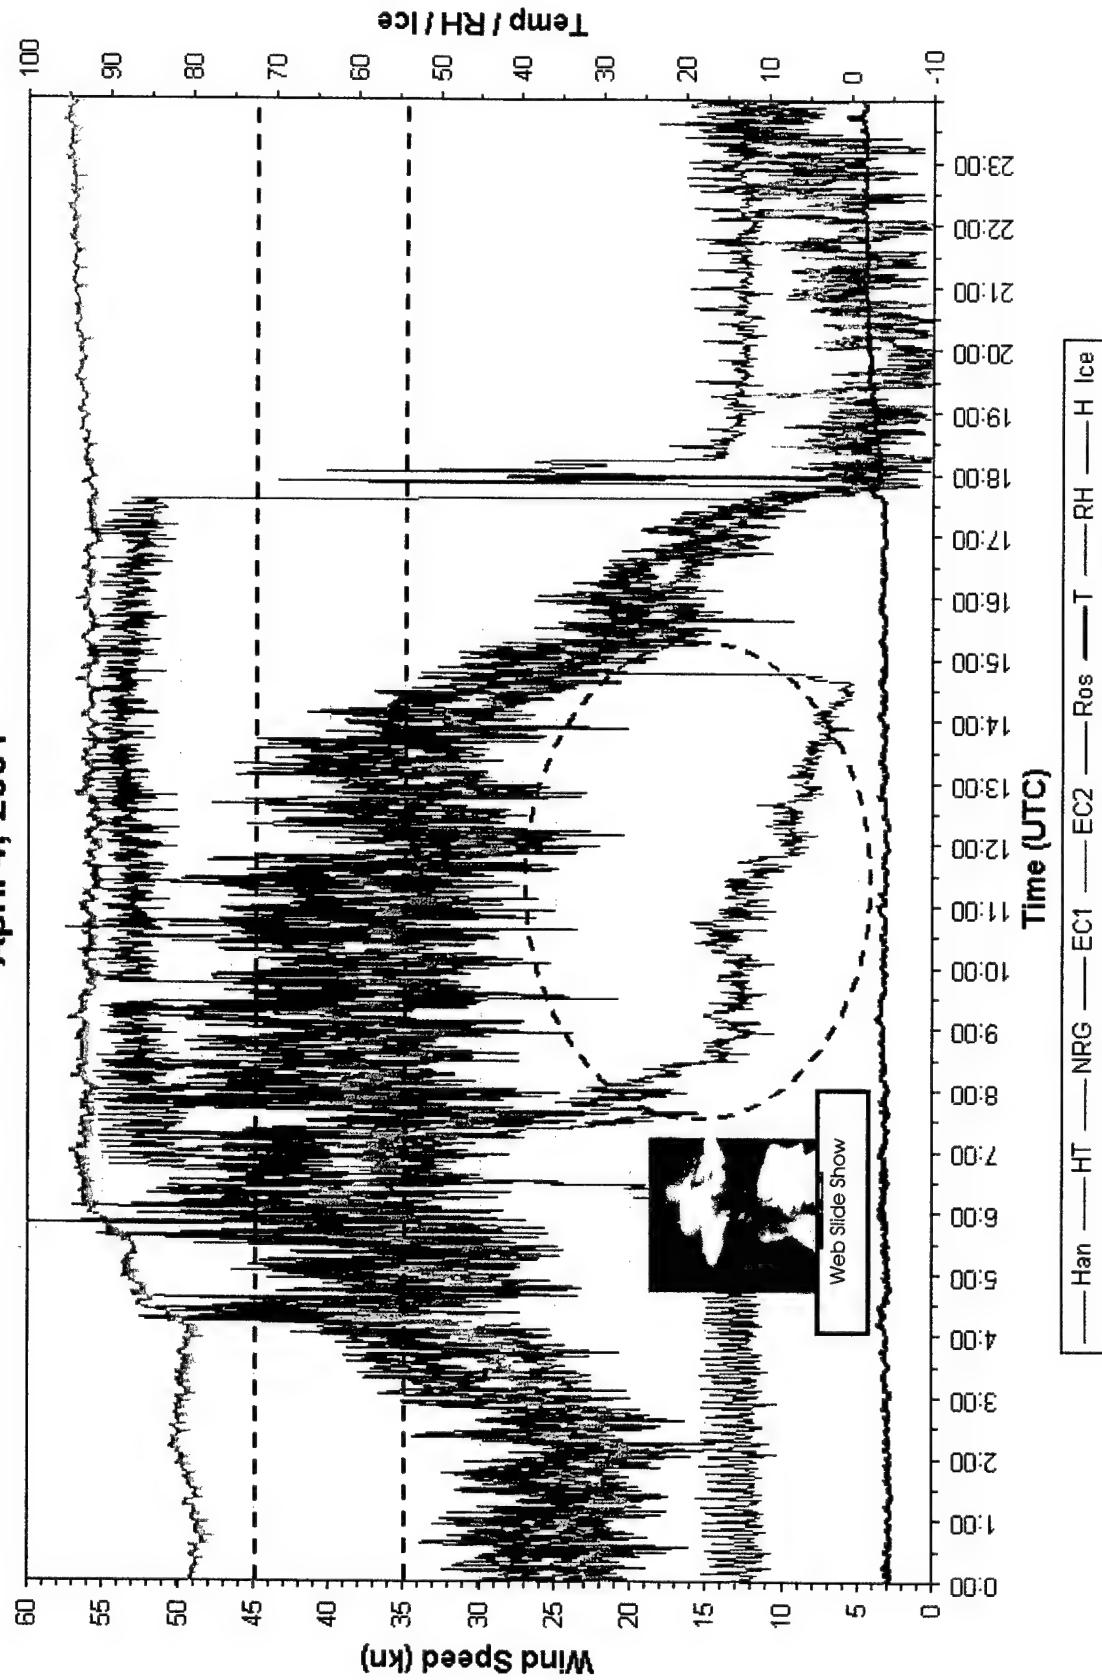
FIGURE 64. NRG ROTOR FAILURE DURING AN ICING EVENT

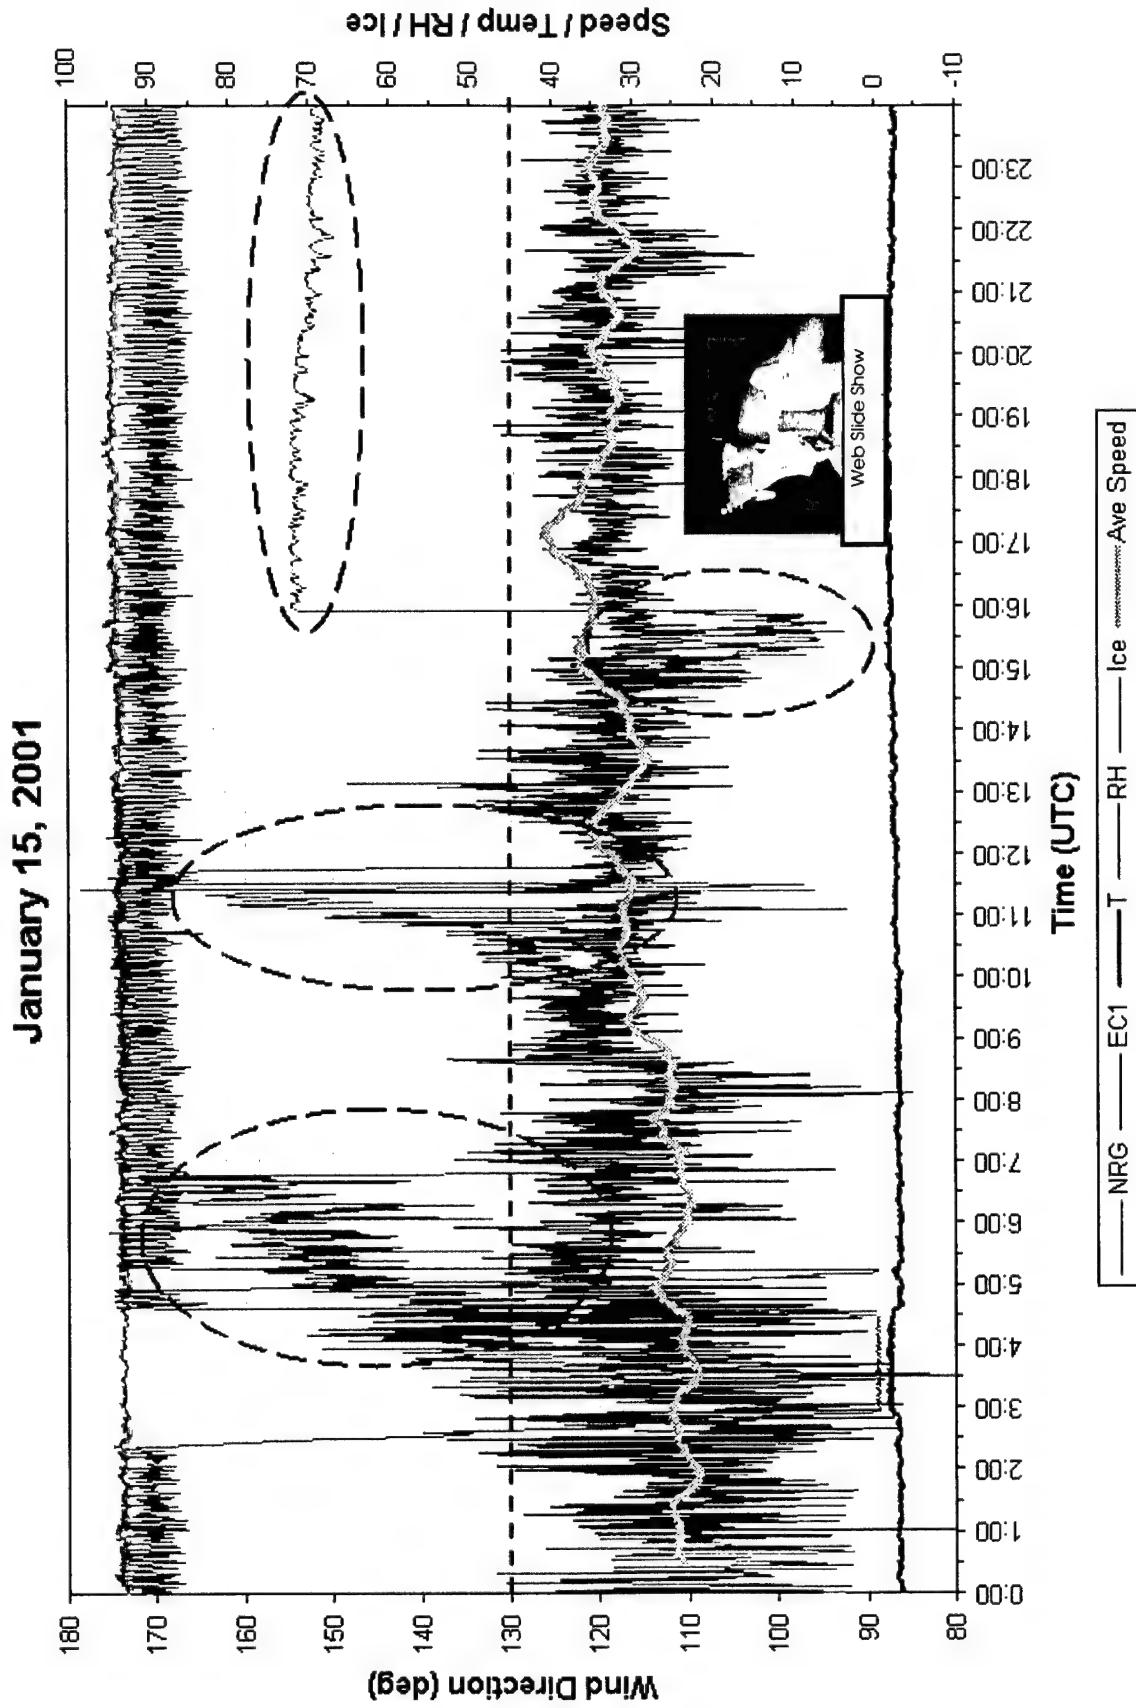
FIGURE 65. NRG DIRECTION VANE FAILURE DURING AN ICING EVENT

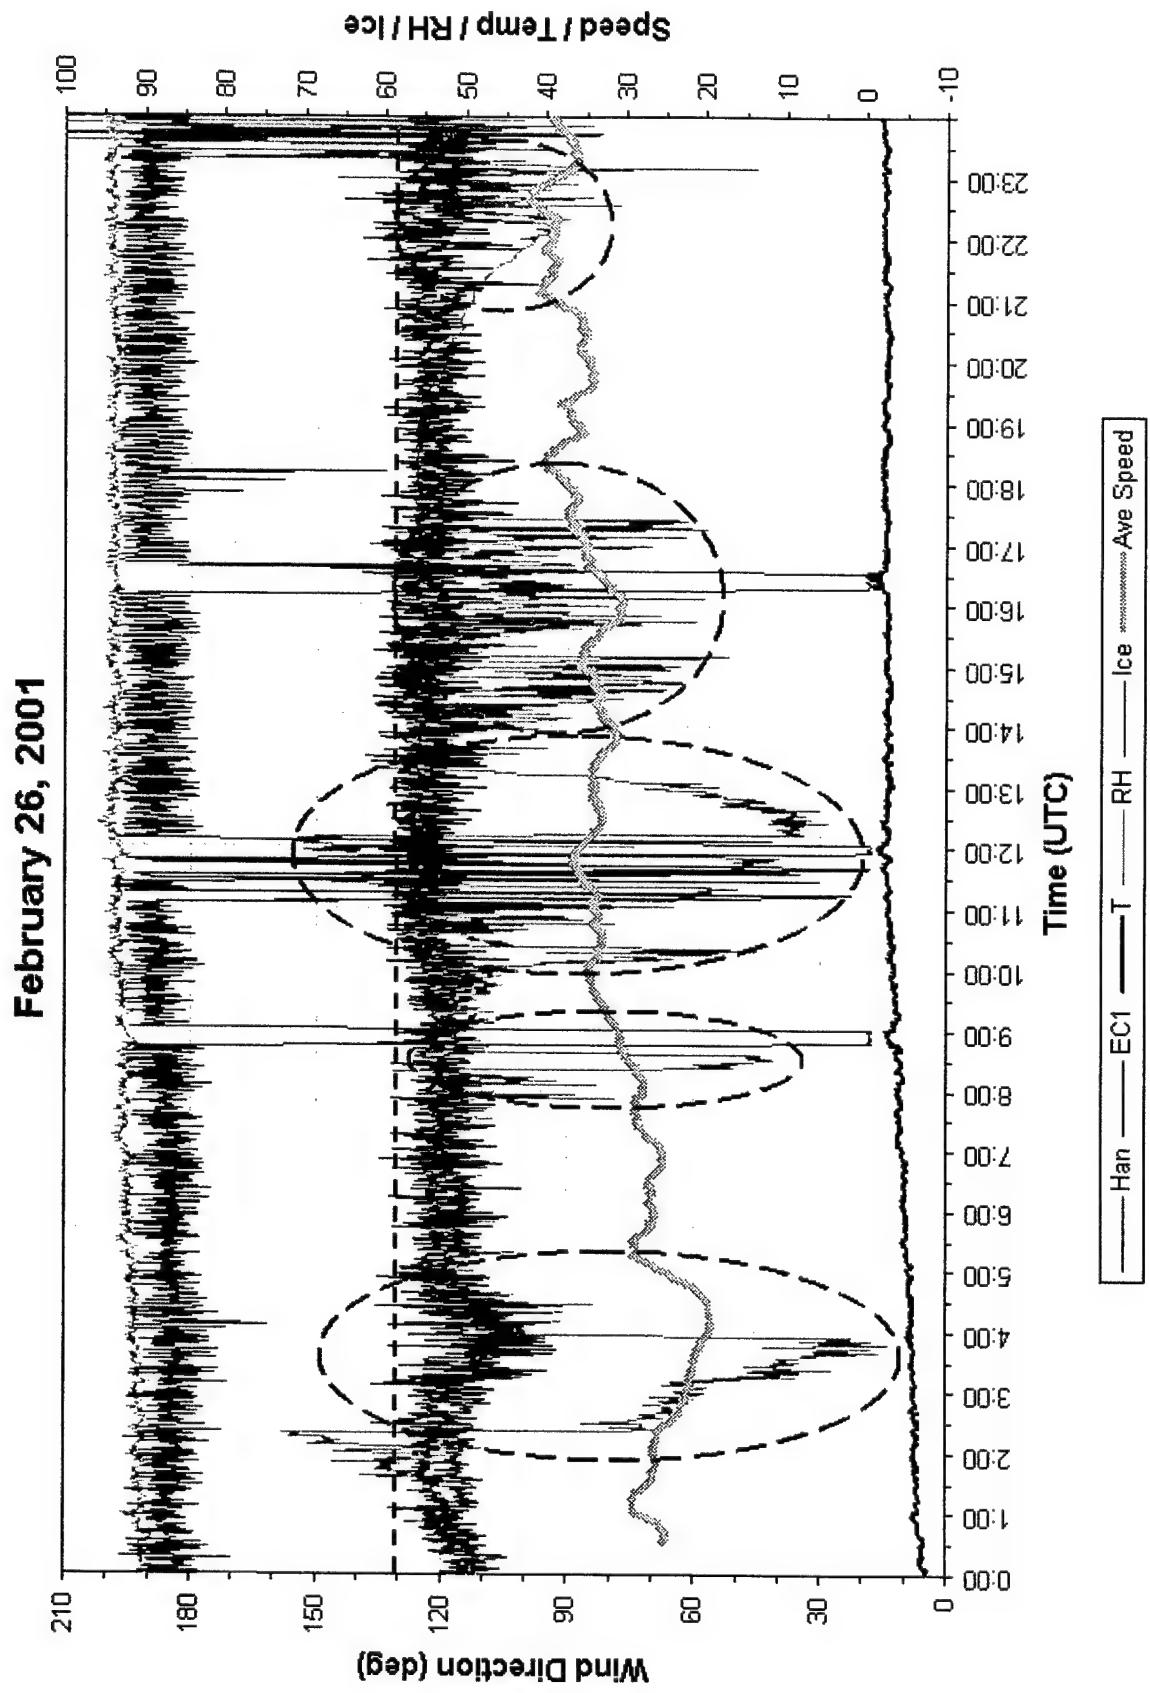
FIGURE 66. NRG DIRECTION VANE FAILURES DURING AN ICING EVENT

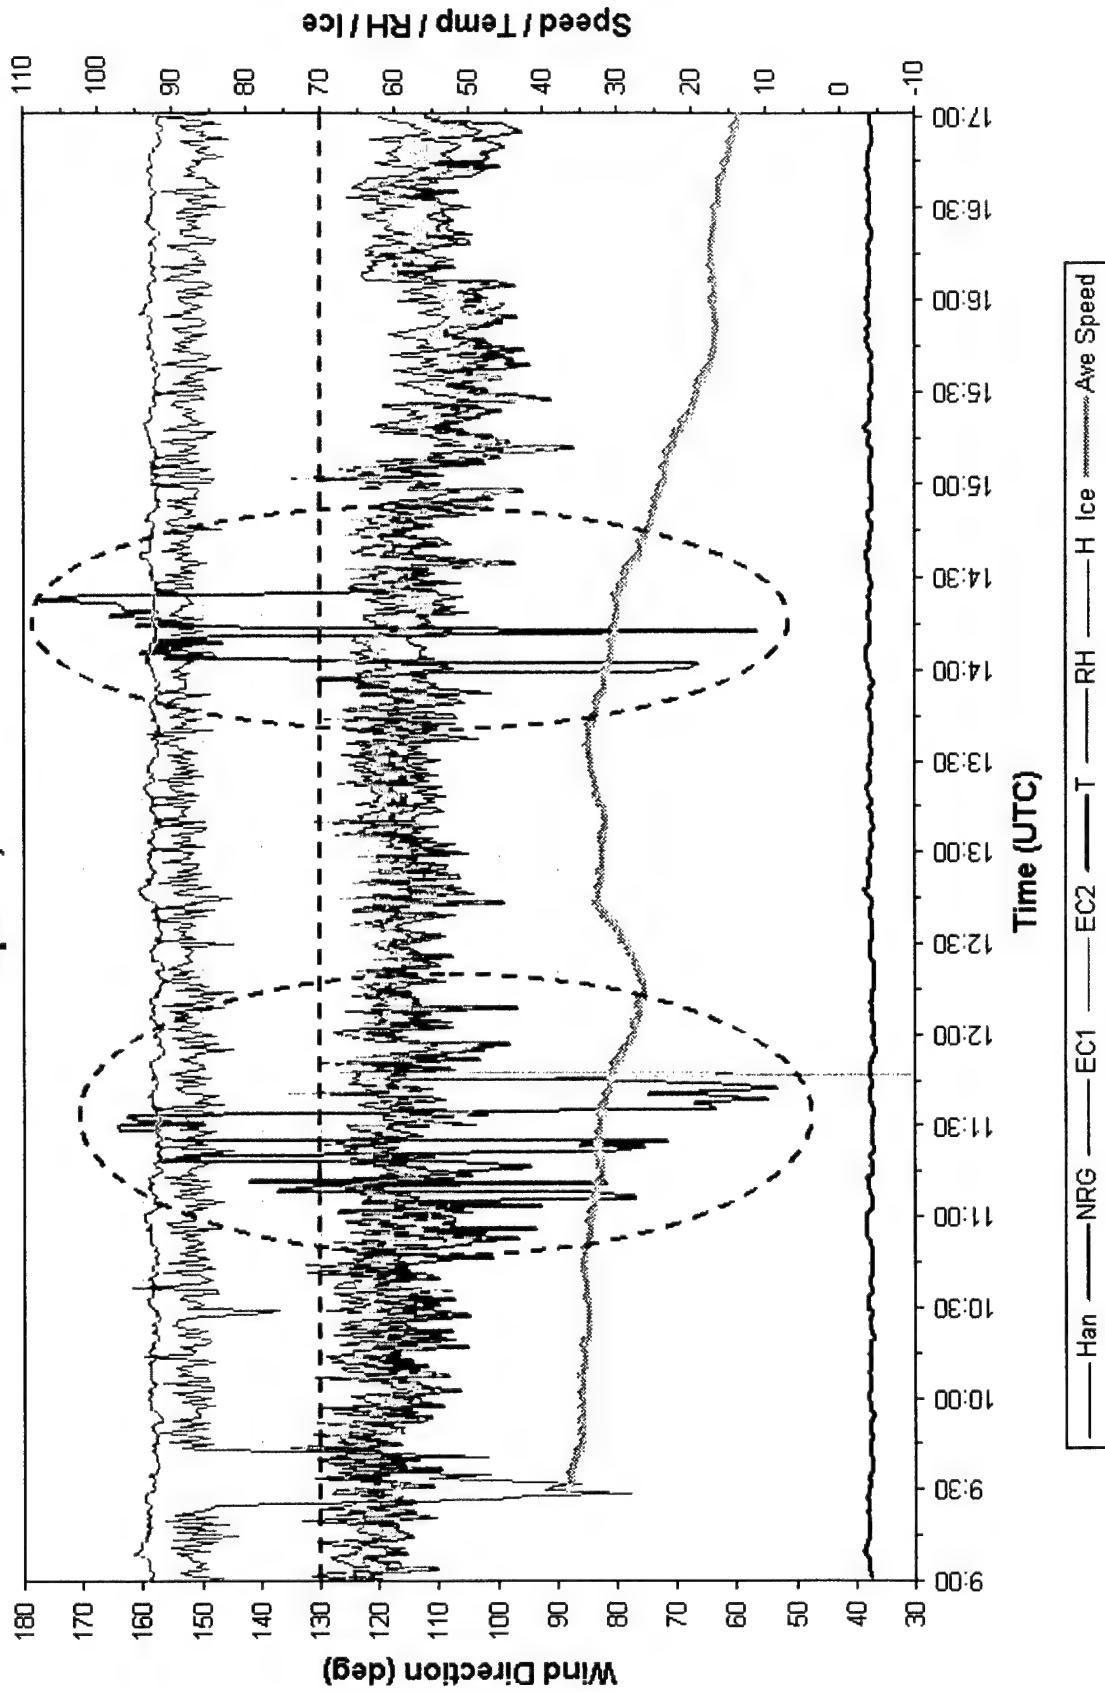
FIGURE 67. NRG DIRECTION VANE FAILURES DURING AN ICING EVENT

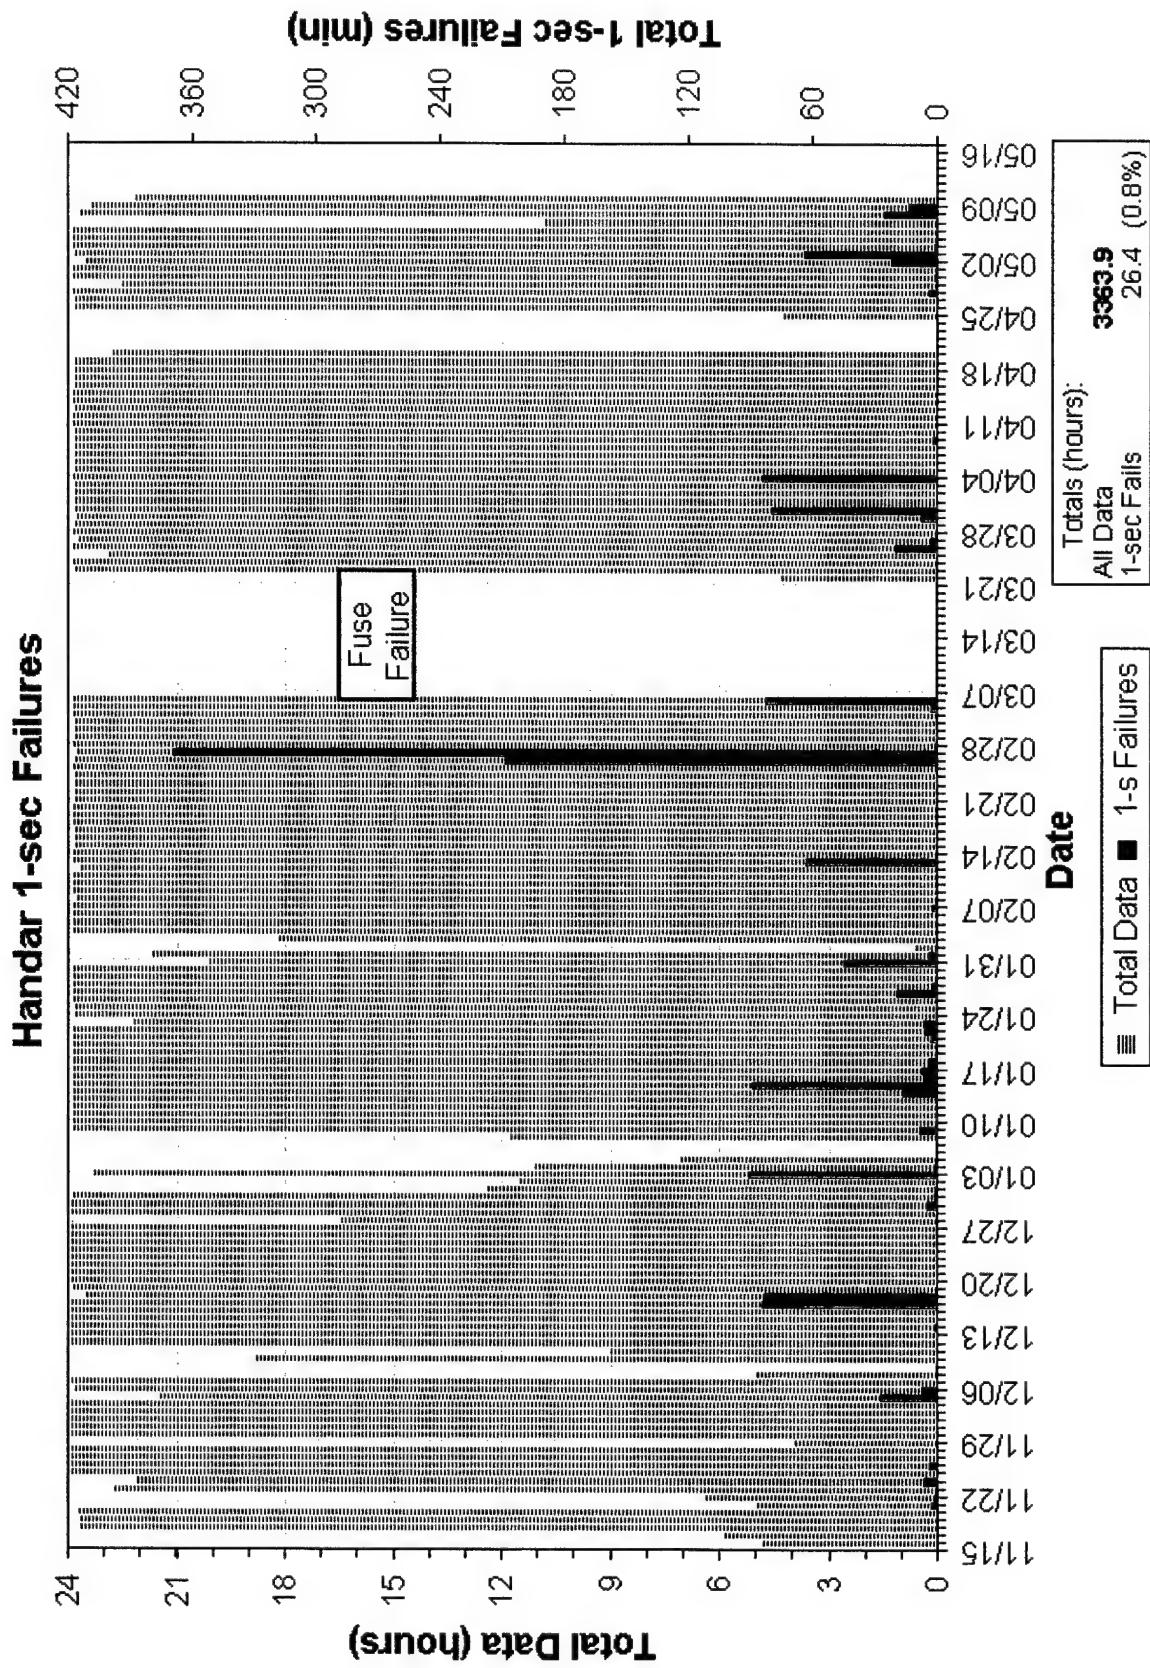
FIGURE 68. DISTRIBUTION OF VAISSALA 1-SECOND SENSOR FAILURES

A total of 3364 hours (~140 days) of sonic anemometer data were recorded and collected. The distribution of failures based on the 1-second raw sensor data is shown in figure 68. The sensor was determined through its internal status, as well as video data, to be degraded by icing 26.4 hours (or 0.8%) of the 6-month period. A failure qualifies as a bad data flag received from the sensor because of unreliable readings. Review of the camera data indicates that the failures appear highly correlated to snow and icing conditions. However, unlike the MWO study where there were instances where the sensor was in complete failure-mode over periods ranging from 2 to 3 continuous hours, the events of sensor failures at JNU were generally intermittent in nature, with frequencies of occurrence proportional to the severity of the weather conditions.

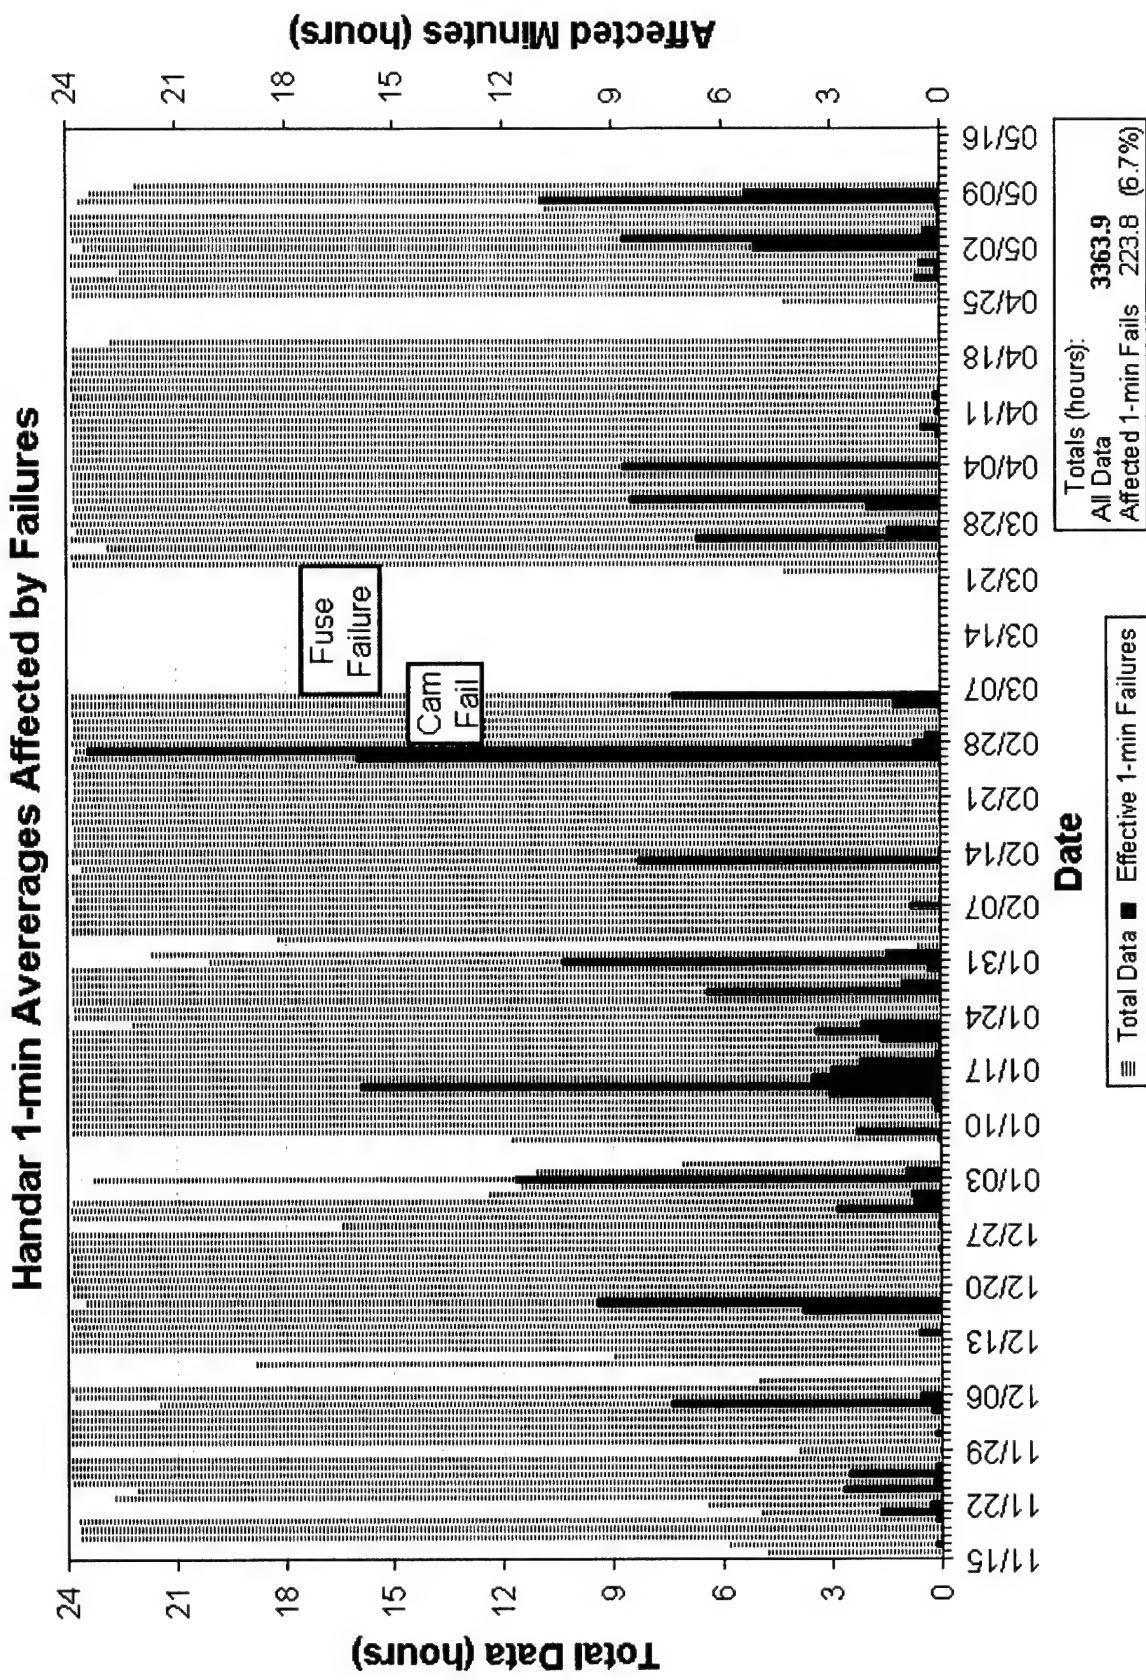
FIGURE 69. DISTRIBUTION OF VAISSALA 1-MINUTE AVERAGES AFFECTED BY SENSOR FAILURES

Further analysis of the periods of degraded performance, with respect to the JAWS 1-minute wind reporting requirement, was next performed. The affected 1-minute averages are shown in figure 69. An affected 1-minute average is a 1-minute mean wind value where at least 1 of the 60 constituent 1-second samples is flagged as bad. The composition of the affected 1-minute averages is reflected in the frequency histograms in figure 70. The analysis revealed that in 84% of affected cases, there were at least 75% raw data samples available to derive a valid wind report. During the entire field experiment, only 81 sporadic 1-minute wind reports were derived from 25% or less raw 1-second samples.

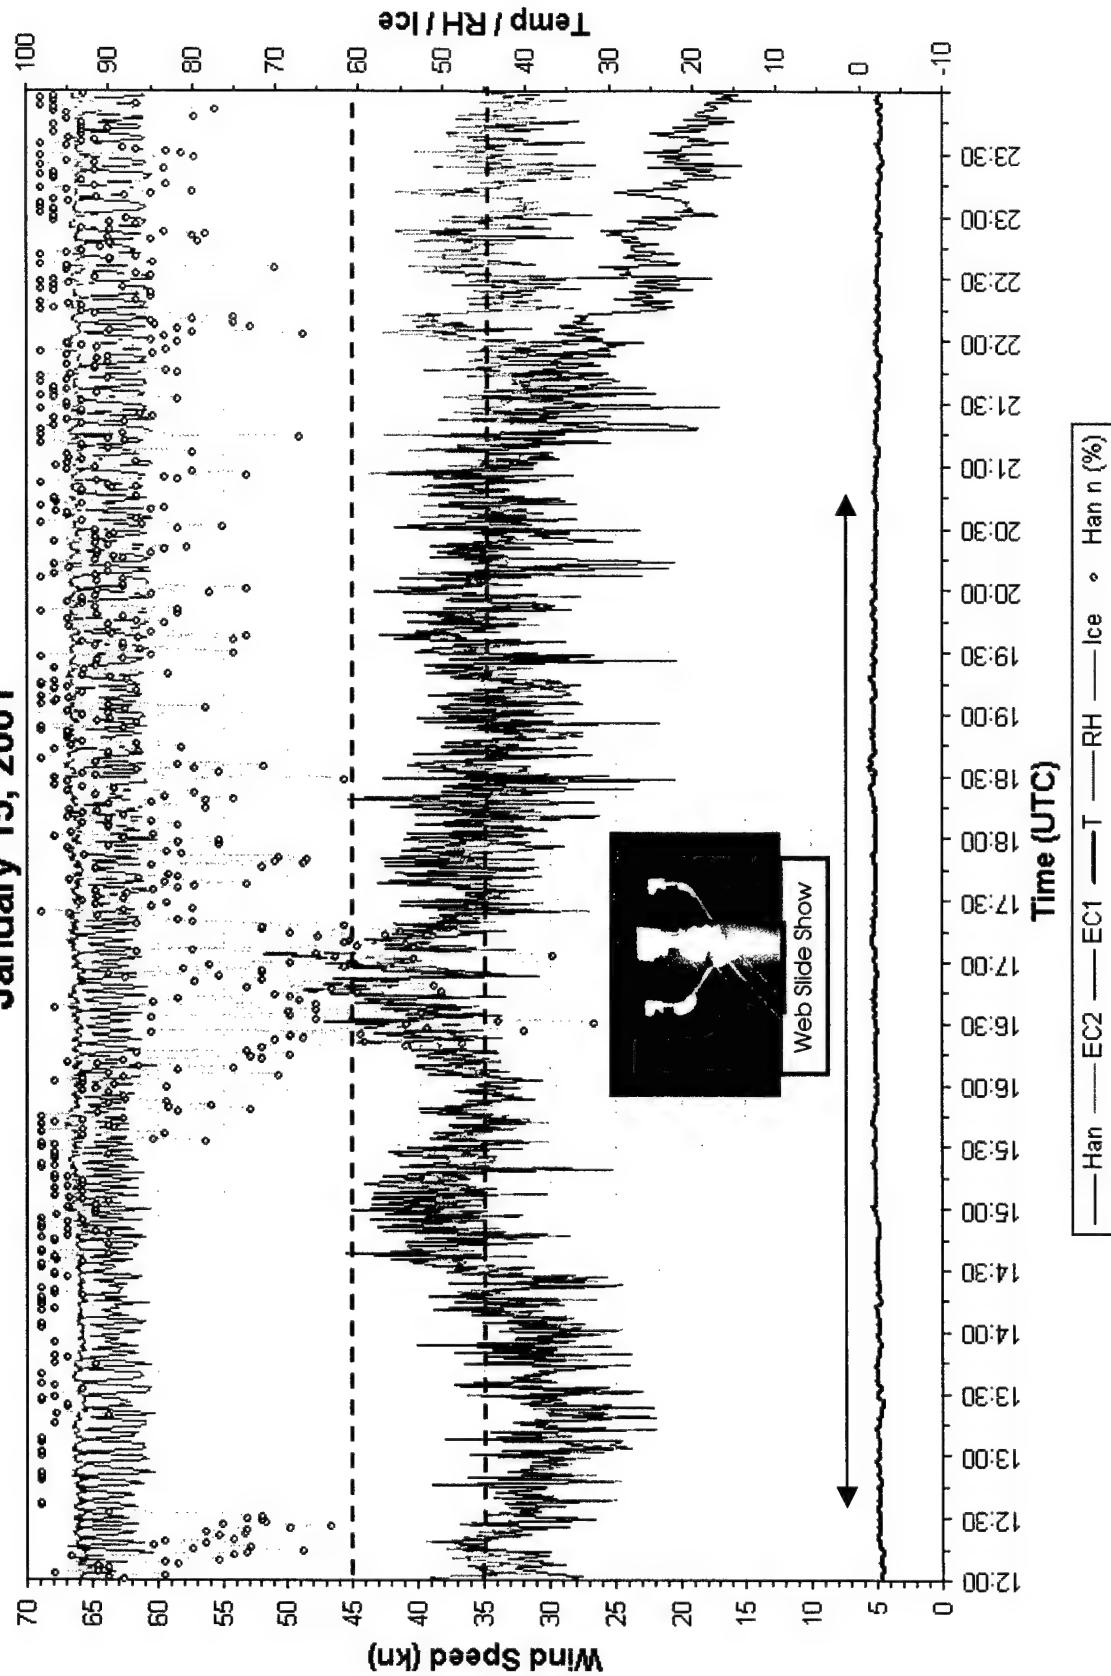
Closer inspection was performed to determine the validity of the affected 1-minute average values when ice was apparent on the anemometer. Time series of Vaisala wind speed and direction values during significant icing events are depicted in figures 71 through 77. In these figures, the sample size of valid data, in percent, comprising the 1-minute averages is shown in yellow against the secondary ordinate axis.

FIGURE 72. VAISSALA 1-MINUTE WIND SPEED AVERAGES DURING AN ICING EVENT

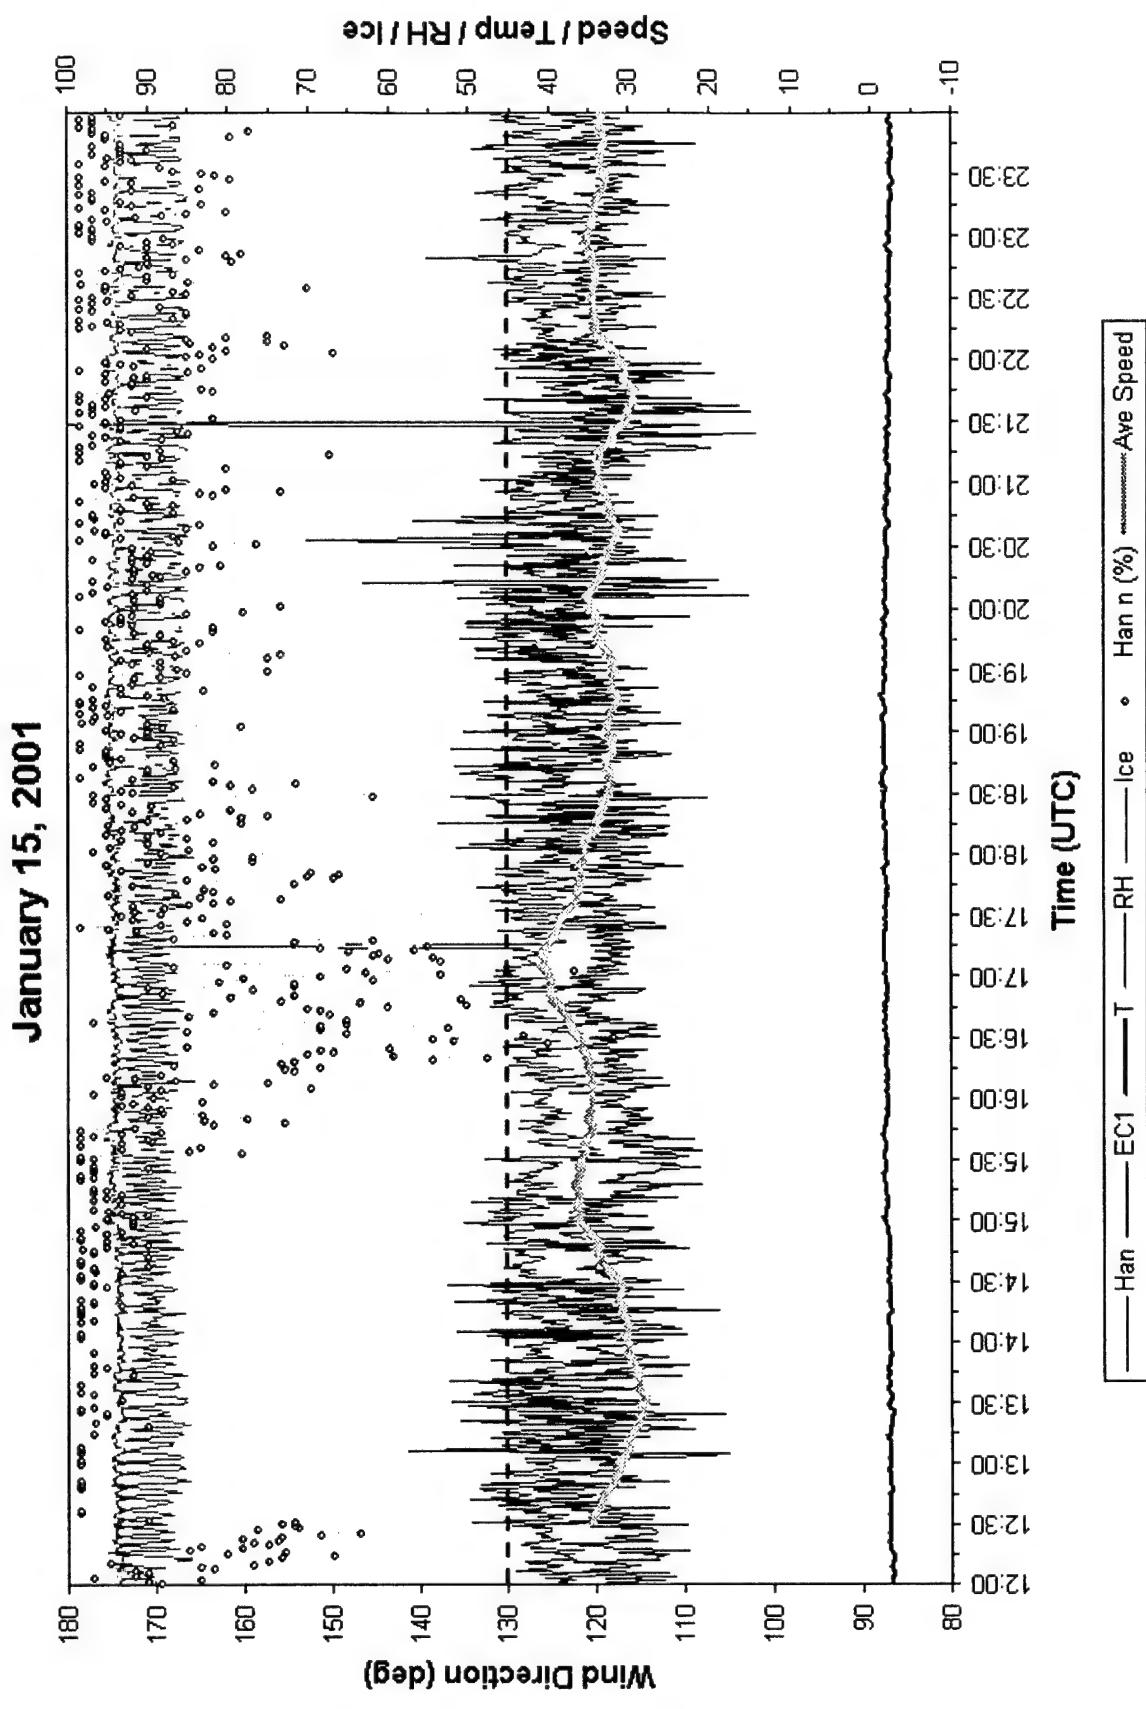
FIGURE 73. VAISALA 1-MINUTE WIND DIRECTIONS DURING AN ICING EVENT
